# Discussion on Control of Facade Styles and Features during Restoration of Huizhou Traditional Buildings

With the Working Method of Wall Surface, Doors and Windows and Fire-Sealing Wall as the Example

By starting from the facade styles and features of Huizhou traditional buildings and taking the project of rehabilitation of historical buildings in Waibianxi, Tunxi District, Huangshan as the example references, this paper analyzed the principles to be held and the specific methods during rehabilitation of facade styles and features of Huizhou traditional buildings in a detailed way in the hope of providing theoretical and technical reference for rehabilitation work of other traditional buildings.

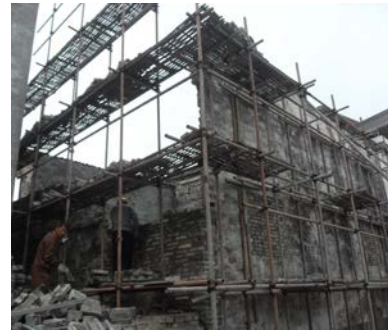
At the early building stage, Huizhou residents often like to plaster with white lime and cover eave with black bricks so as to reach the façade artistic effect of "White walls and black titles". However, as most of old dwelling walls are bricked external plastering, under the erosion of wind and rain, the lime of some external wall surface falls off and the moss grows thickly for years. The components in weak parts such as fire-sealing gables and door covers even showed different degrees of damage.

FIG. 2 SERIOUSLY DAMAGED EXTERNAL FACADES

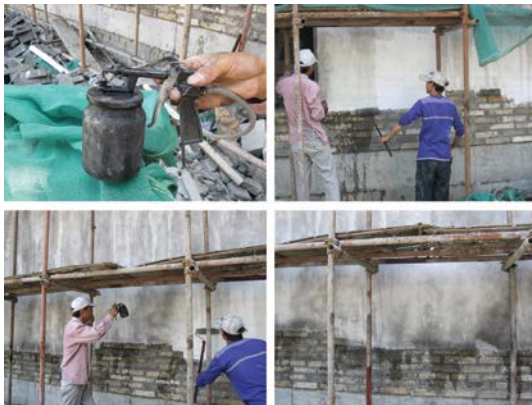
FIG. 3 MAKING-REPLICA METHOD OF WALL

Due to years of exposure to wind and rain, the previously painted coating of existing wall has cracked and fell off. In order to restore its original appearance, the new coating shall be painted at external surface in restoration. However, in case the main part of old building is painted with the new wall surface, it would be unreasonable. Thus, the method of using manual sprinkling of special preparation on the new painting layer will be adopted so as to achieve the uniformity of style and feature of façade. This kind of special preparation is prepared with mixed and fermented with ink, stick rice water, brick powder, tea juice and fungus juice. The specific method is to put the preparation in sprinkling can and then sprinkle a layer of water to the lime surface layer of wall at first. The purpose is as the mark left on wall surface by directly sprinkling with sprinkling can is the dot shapes in different sizes instead of the unnatural facets. At first, sprinkle the water and then sprinkle the preparation to make preparation and water integrate and disperse just like in ink and wash painting. At last, spread unevenly with cleaning cloth to form the natural dispersing mark (Figure 3).

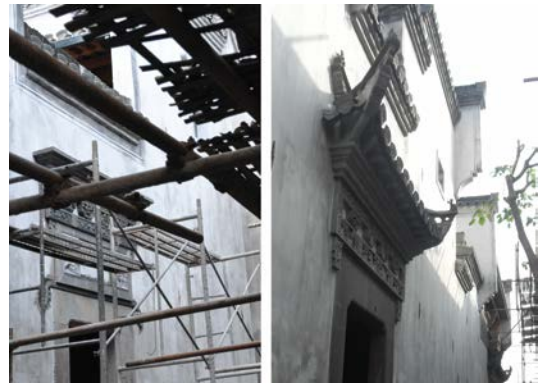
FIG. 4 COMPARISON OF DOOR COVERS BEFORE AND AFTER RESTORATION

Door cover extrudes from main part of wall. The exquisite brick and stone caving artistic work that are decorated above door cover of bar has a rich content, broad range of topics and the fine caving. Although having gone through the wind and rain, its original exquisite and prosperity can still be seen. During restoration, rebuild the damaged part in accordance with original appearance, mix the paint similar to the color of existing part and paint it on rebuilding parts. In this way, no acosmia feeling brought by the

difference between new and old color can be avoided.

There is a small overhanging eave at the place above the window of external wall. As the window of external wall has a small opening and is less used, the function of shading and rain sheltering of this overhanging eave gradually degrades. During restoration, in case there is any damage, it only need to make two to three layers of brick and stone narrow eave shape ornamental elements for meaning and symbolization function at the place 30 centimeter above eave. The curling up of two ends of narrow eave represents the original overhanging eave wing angle (Figure 4).

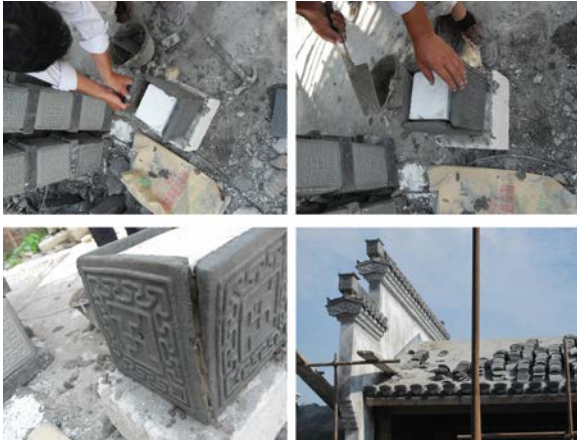
FIG. 5 FABRICATION OF AIR EXHAUSTING HEAD OF FIRE-SEALING GABLE

For the damaged verge, tiles shall be used for pilling up during restoration. The components of air exhausting head are prefabricated in factory and then be assembled at site. The specific process is as follows: place the standard reference object whose dimension is determined through calculation in the middle part, then affix the pre-casted tile carving components with cement mortar

to the four surfaces in surrounding, and at last, splice the component of top surface with the four edges of four components below with cement mortar and strengthen with nails at geometric center of each component to form an integral part (Figure 5).

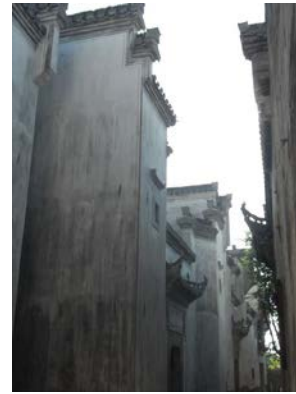
FIG. 6 FACADE EFFECT AFTER RESTORATION

After repairing, the elegant appearance at the time of first establishment of wall surface that was damaged is reproduced. And the exquisite details of eaves of doors, windows and horse head are restored one by one too. The restored Waibinxi is presented in its integral and charming facade form, which will not only become a scenery line beside Xin'an River, but the theories and technical means which are used during its facade style and feature's restoration process will certainly become the references for restoration projects of similar traditional buildings (Figure 6).
